Buckrigger Block Inspection Notice

INSPECTION NOTICE for all Buckingham PN 5007R1 and PN 5007R2 BuckRigger™ Blocks manufactured prior to December 2022.

January 11th, 2023

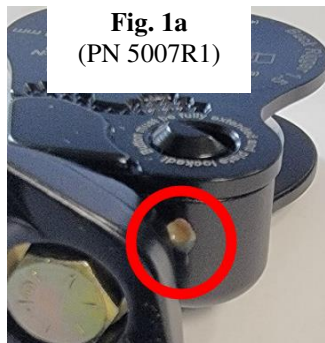
Fig. 1a
(PN 5007R1)

Buckingham Mfg. Co. has been notified by a contract supplier, that the button assembly on a limited number of Buckingham PN 5007R1 and PN 5007R2 BuckRigger™ 1.5 blocks (Fig. 1a – 1b) may not be secure. If the button comes out the side plate can open, allowing the rope to fall out which can result in serious injury or death. It was discovered that a small number of pulleys may not have had adequate thread locker or sealant, allowing the set screw to back out. Under normal circumstances, either the thread lock or sealant is adequate to secure the button and prevent this issue.

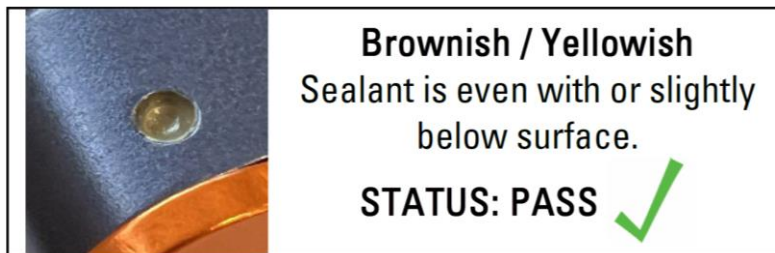
1. Identify the location of the set screw on the BuckRigger™ block, PN 5007R1 and 5007R2 and compare your block to the images below. Does your block have the sealant present and properly applied? The sealant should be brownish yellow to white / grey in color and be even or slightly below the surface of the aluminum body (Fig. 4a – 4b). If **“YES”** no further action is required.

Note: If the sealant is the proper color and is filling the hole as shown in Fig. 4a – 4b, but there is excess sealant on the surface of the aluminum body, this is not a failure. Sealant above the surface is referring only to the sealant in the hole extending above the surface (which could indicate an improperly installed set screw) and not spilled or overflow of the sealant.

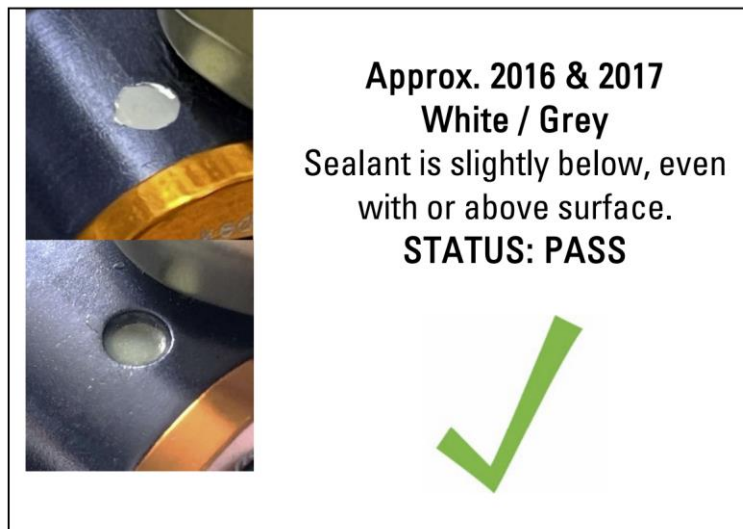
Fig. 6

1. Identify the location of the set screw on the BuckRigger™ block, PN 5007R1 and 5007R2 and compare your block to the images below. Does your block have the sealant present and properly applied? The sealant should be white / grey in color and be slightly below, even with or above the surface of the aluminum body (Fig. 6). If **“YES”** no further action is required.

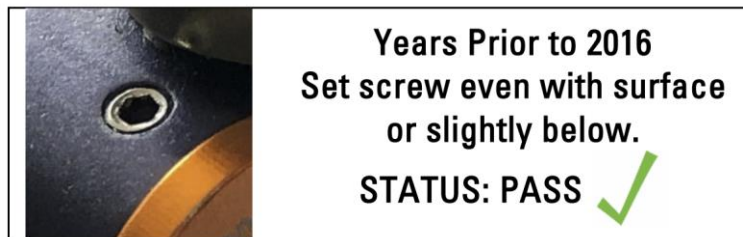
Fig. 8

1. BuckRigger™ manufactured prior to 2016 were made differently. The button set screw has thread lock but no sealant on top of it. Identify the location of the set screw on the BuckRigger™ block, PN 5007R1 and 5007R2 and compare your block to the images below. Is the set screw even with or slightly below the surface of the aluminum body (Fig. 8). If **“YES”** no further action is required.
