Buckrigger Block Inspection Notice

INSPECTION NOTICE for all Buckingham PN 5007R1 and PN 5007R2 BuckRigger™ Blocks manufactured prior to December 2022.

January 11th, 2023

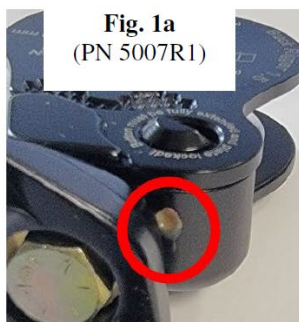
Fig. 1a
(PN 5007R1)

Buckingham Mfg. Co. has been notified by a contract supplier, that the button assembly on a limited number of Buckingham PN 5007R1 and PN 5007R2 BuckRigger™ 1.5 blocks (Fig. 1a – 1b) may not be secure. If the button comes out the side plate can open, allowing the rope to fall out which can result in serious injury or death.

It was discovered that a small number of pulleys may not have had adequate thread locker or sealant, allowing the set screw to back out. Under normal circumstances, either the thread lock or sealant is adequate to secure the button and prevent this issue.

Specific manufacturer inspection instructions follow this page. Please review that guidance. Remove from service and send back to Buckingham if any block fails inspection.
